DuPont global PV reliability

2020 Field analysis

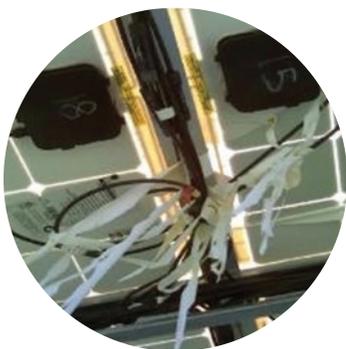
5 years
Eastern Canada

There have been observed many examples of widespread backsheet through-cracks.

- These failures are prevalent along busbar ribbons, but with continued weathering can extend to cell gaps and other regions.
- Arcing and shorts often lead to localized burn-through and sometimes full module fires.
- Reported inverter tripping and ground faults.

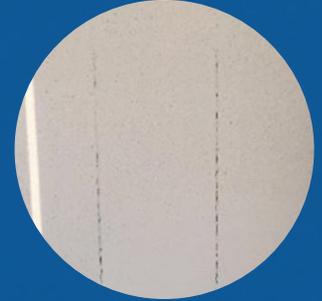
A photovoltaic plant in France discovered that, after 8 years of use, performance of their modules was declining year over year and that many modules were displaying widespread backsheet cracking. This had led to a degradation of insulation resistance (IR) in the solar modules over time, leading to unsafe working conditions as a result of electrical hazards. All PA backsheets and 10% of PVDF backsheets exhibited cracking.

**Widespread
backsheet cracking**
PA

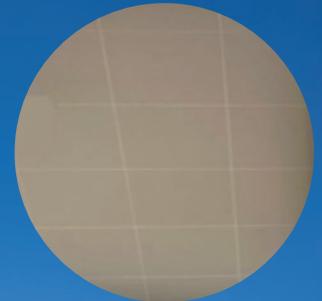
No defect
Tedlar® PVF
