# Capitalizing on a failure

CASE HISTORY

## The up-rate process

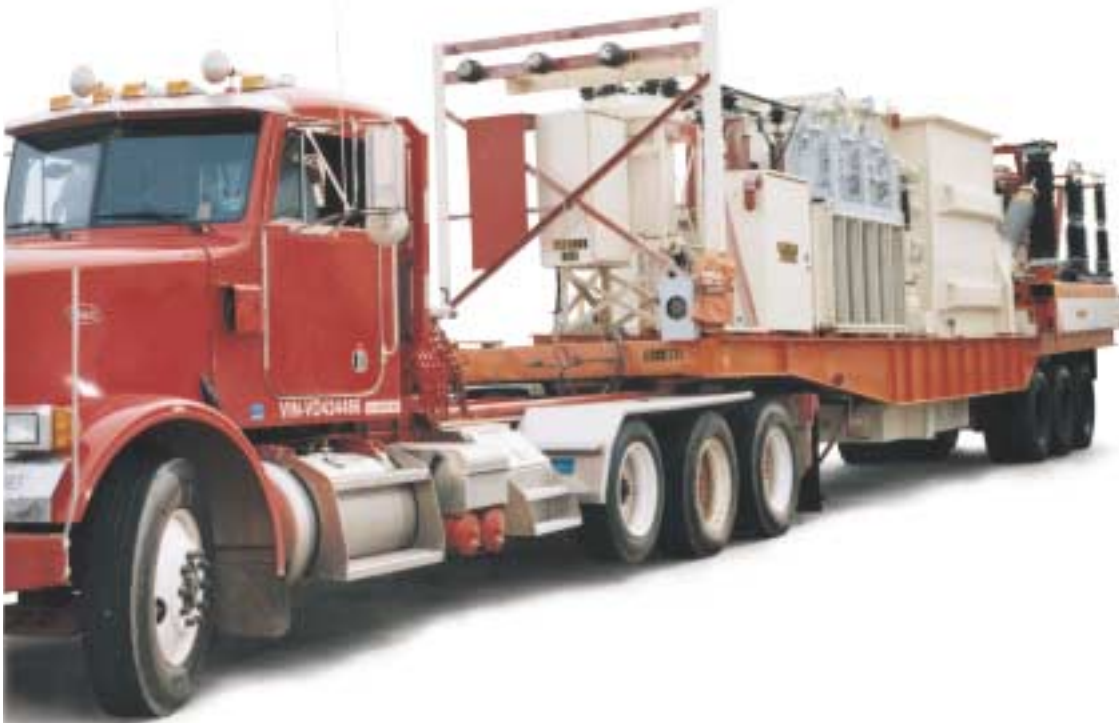
In a typical hybrid insulated core-form transformer repair, the hot areas requiring NOMEX® brand insulation are limited to conductor wrap, radial spacers and axial sticks, as is shown in the picture of the NIMO unit above. This usage results in a unit with a 95°C average winding rise. In another option, Southwest also has rebuilt transformers using NOMEX® as a conductor wrap only. This results in a 75°C rise unit with a smaller capacity increase (see "Another repair option" on the next page).

the control power was originally supplied from a few independent turns wound on the main transformer. With the redesign by the engineers at Southwest, control power is now supplied by a separate control power transformer (CPT) mounted and connected externally to the main tank. Now if it were to fail, damage would be minimal and far less costly to repair.

Additionally, the aluminum tank itself, which had been damaged by the force of the failure, was repaired and strengthened. All controls were tested and verified. The unit was refitted with new gaskets, and the high-voltage bushings were replaced. Southwest Electric also improved the short circuit withstand rating of the transformer.

As part of its long-standing policy toward mobiles, Southwest specified the use of copper conductors wrapped with NOMEX® insulation. The repair company does this whenever possible, even when the customer doesn't require it. NOMEX® has a much higher tensile strength than cellulose insulation; thus it offers exceptional resistance to tearing and is far less prone to becoming brittle with use. By habitually going beyond what's expected, Southwest demonstrates a genuine commitment to providing clients with the highest quality and value.
