Customer Success Story

Subzero Operating Conditions Are No Match for FILMTEC™ Seawater Reverse Osmosis Elements

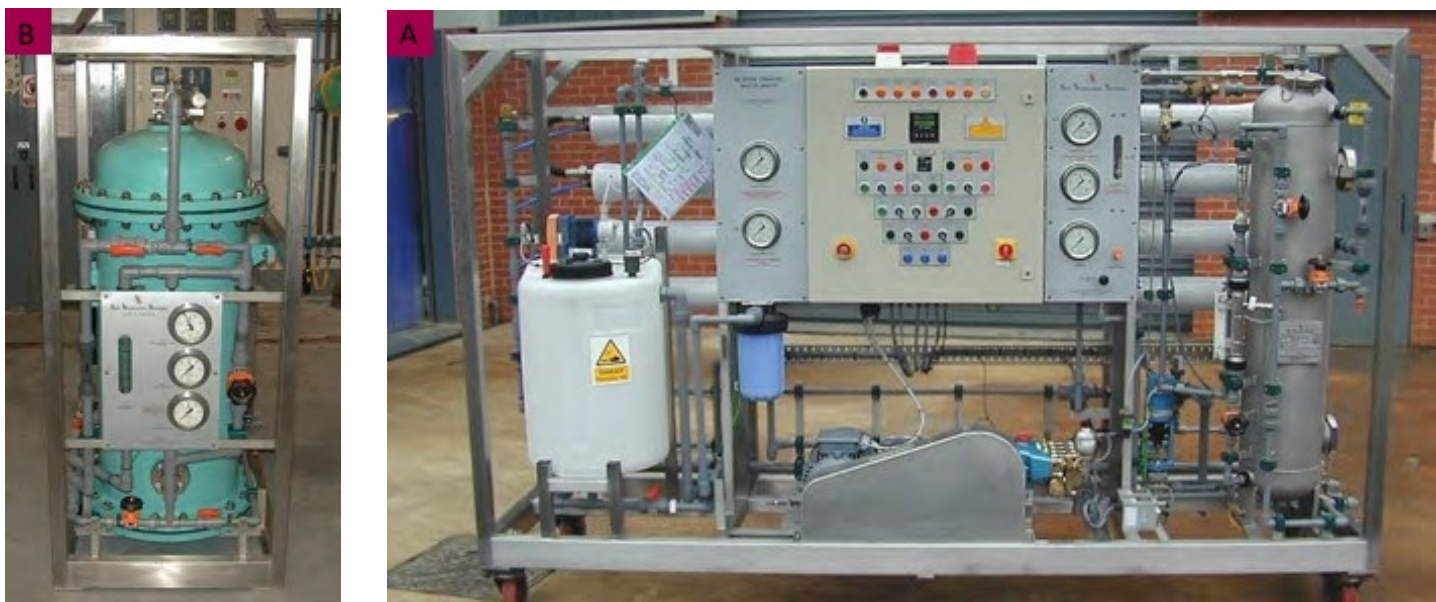
Figure 1: Images of Rothera plant (A. Sand filter and B. RO unit), courtesy of Salt Separation Services, UK.

The Rothera unit, shown in Figure 1, and Signy unit consist of self-contained skid mounted plants, including: sand filter, cartridge filters, antiscalant dosing (Rothera only), a clean-in-place (CIP) system and rehardener.

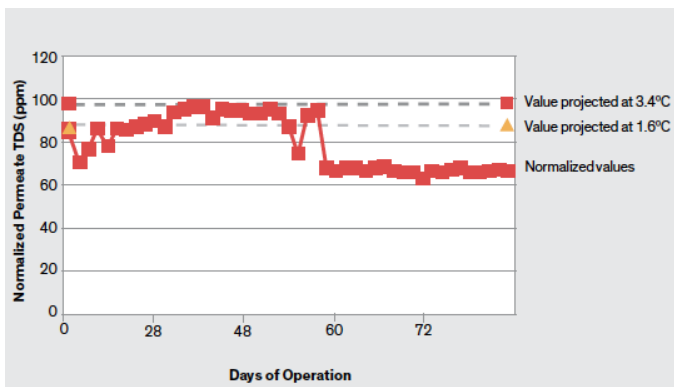
Figure 2: Normalized permeate TDS registered at Rothera plant.

In the first two and a half months of operation, the normalized salt rejection and permeate flow data was collected almost daily. During this time, the temperatures were between 3.4 and 1.6 °C, as shown in Figure 2 and Figure 3.

The values in Figure 2 are compared to a DuPont system design tool, Reverse Osmosis System Analysis (ROSA). The data values, equal or lower than the ROSA projected values, show excellent element performance.

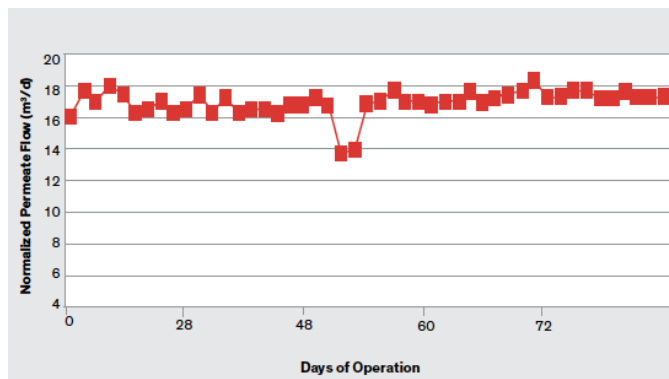
Figure 3: Normalized permeate flow registered at Rothera plant.

The normalized permeate flow remained very stable during the data collection timeframe, indicating no effect of long term low temperature operation.
